## TECHNICAL MEMORANDUM

DATE: March 31, 2025

Project No.: 940-80-24-10 350

SUBJECT: Expansion of the Borrego Springs Subbasin Groundwater  
Monitoring Program and Conversion of Inactive/Abandoned Wells

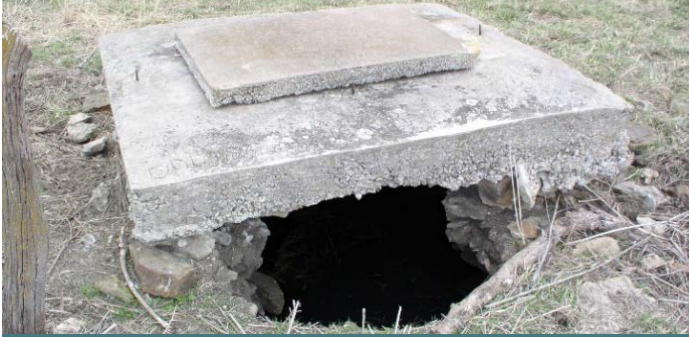
Example of an uncovered Abandoned well

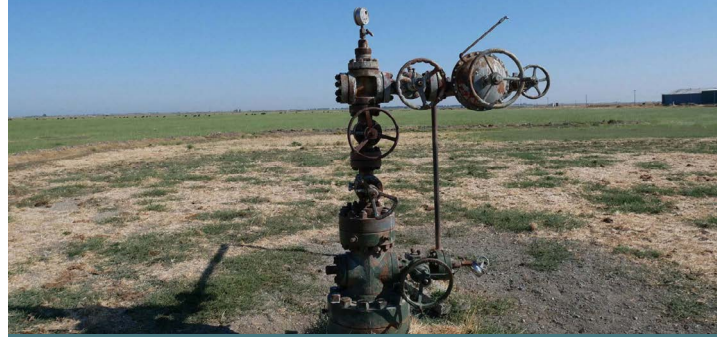
Example of an Abandoned well with pump still intact

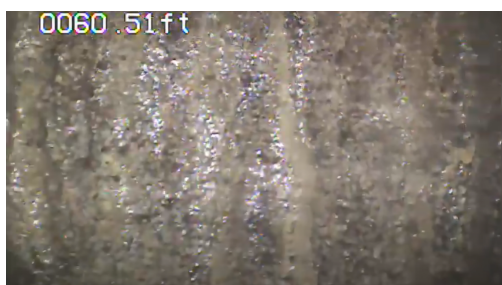
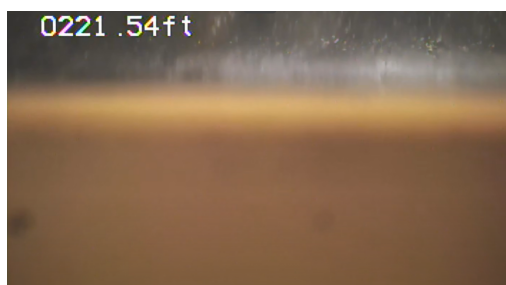
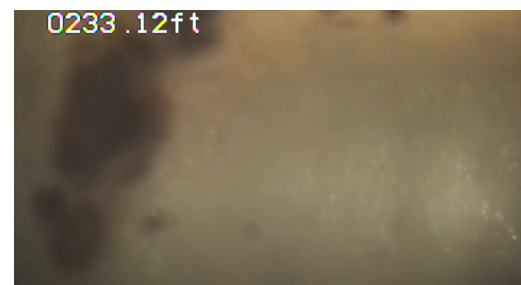
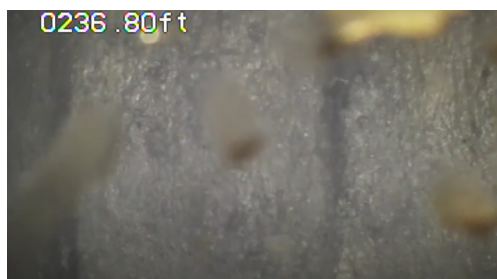
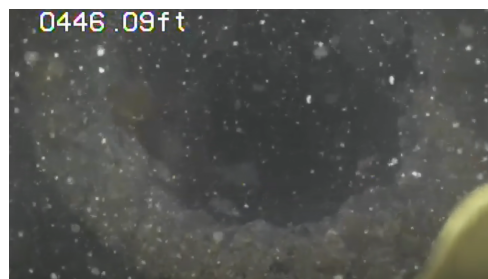
Depth	Video Findings	Casing / Perforation Information	
		Casing Size:	Depth
60'	Build up on casing		
221.53'	Oil	14"	
233.12'	Water		
235'	Perfs		
444.28'	Well diameter reduced		
448.90'	Camera stuck, won't go further		
		<b>Perforation:</b>	
		235'

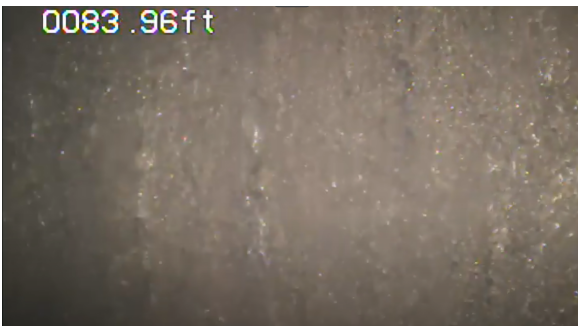
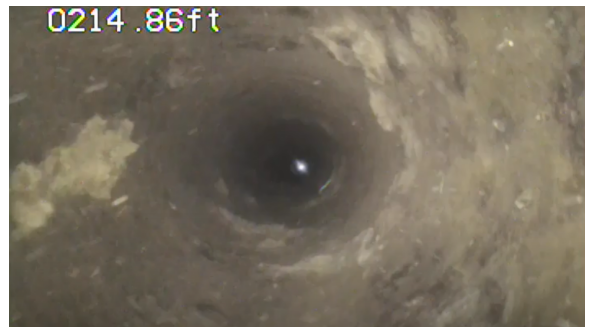
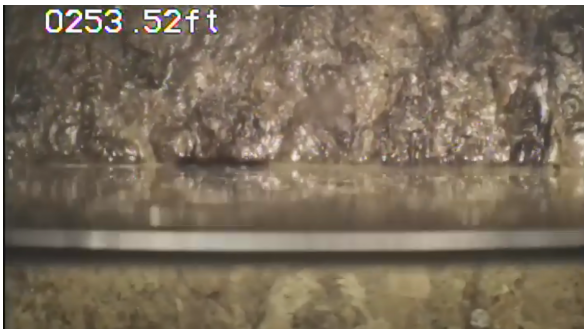
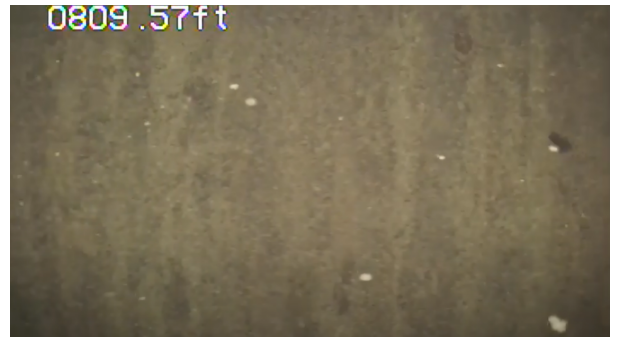
Depth	Video Findings	Casing / Perforation Information	
	Buildup on casing to bottom	Casing Size:	Depth
		16"	809.60'
		Perforation:	Perforations not visible
