## TECHNICAL MEMORANDUM

DATE: March 31, 2025

Project No.: 940-80-24-10 350

SUBJECT: Expansion of the Borrego Springs Subbasin Groundwater  
Monitoring Program and Conversion of Inactive/Abandoned Wells

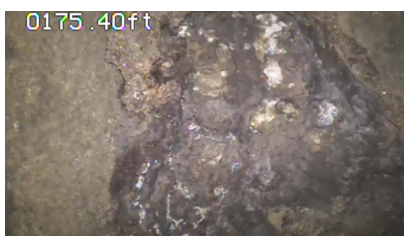
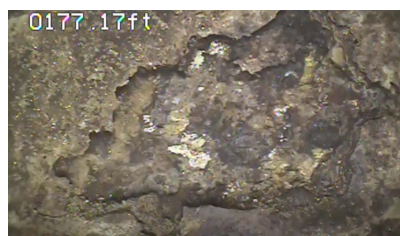
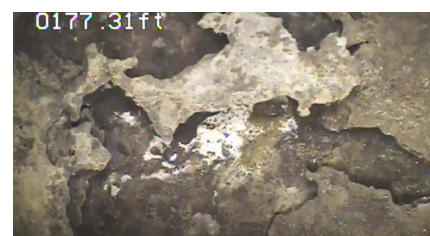
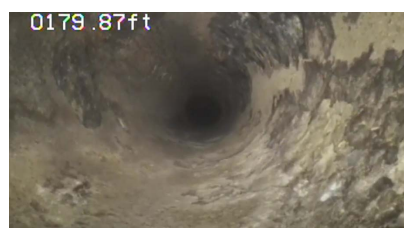
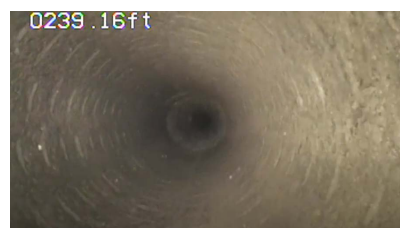
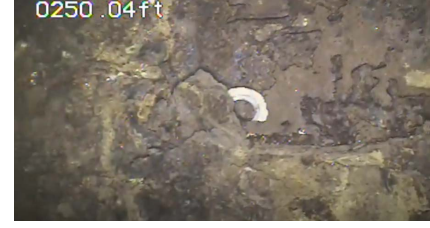
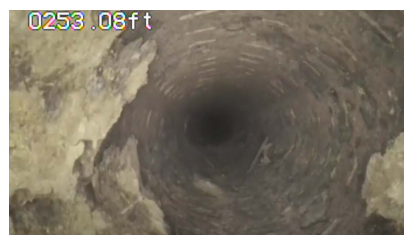
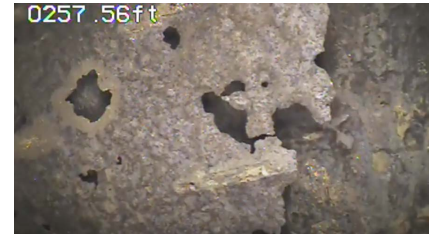
**Date:** January 28, 2025  
**Depth:** 355'  
**Water Level:** 350.55' **Oil?** Little  
**Operator:** Carter **Truck:** Service  
**Tool Zero:** \_\_\_\_\_  
**Reason for Video:** Inspection

Depth	Video Findings	Casing / Perforation Information	
		Casing Size:	Depth
170'-190'	Casing falling apart	14"	355'
240'	Looks like casing reduces		
240'	Perfs		
240'-280'	Casing is falling apart		
240'	Down build up on pipe to bad had to pull out and make stabilizer smaller		
		<b>Perforation:</b>	
		240'

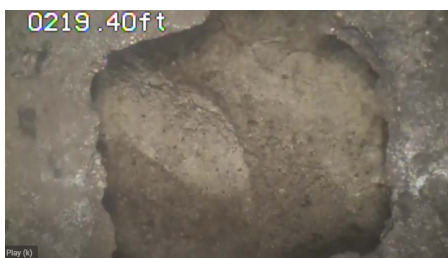
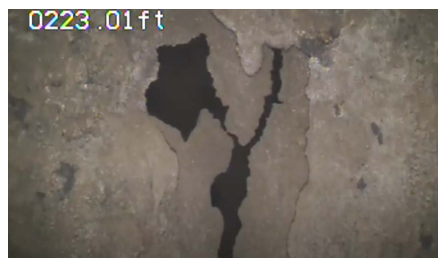
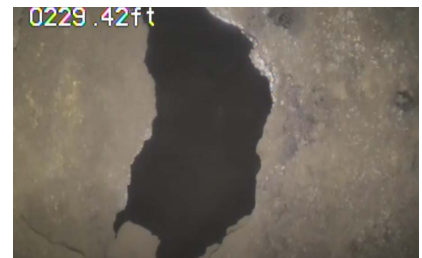
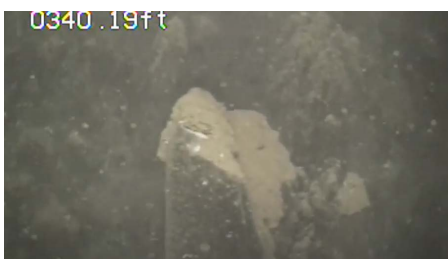
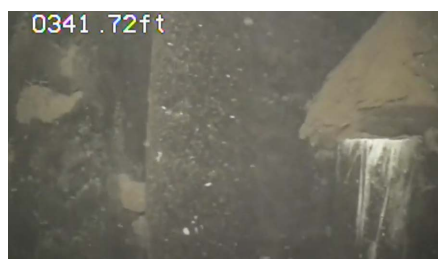
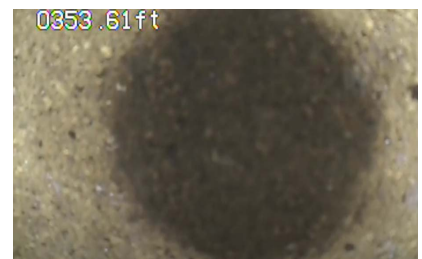
Date: January 28, 2025  
 Depth: 353.61'  
 Water Level: 312.49' Oil? \_\_\_\_\_  
 Operator: Carter Truck: Service  
 Tool Zero: \_\_\_\_\_  
 Reason for Video: Inspection

Depth	Video Findings	Casing / Perforation Information	
		Casing Size:	Depth
60'	Build up on casing		
219.40'	Hole in casing	14"	353.61'
223.09'	Hole in casing		
229.42'	Hole in casing		
340.19'	Piece of PVC		
341.74'	Piece of PVC		
		Perforation:	Perforations not visible

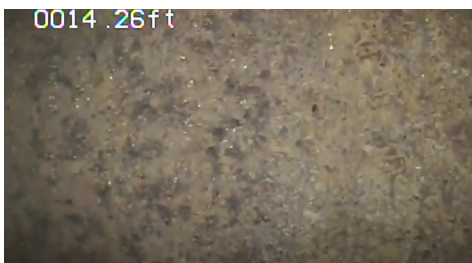
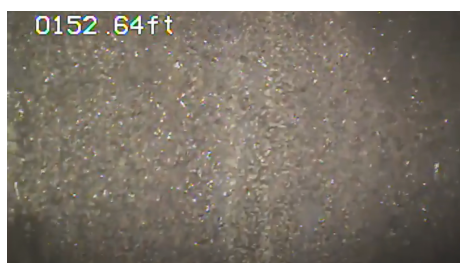
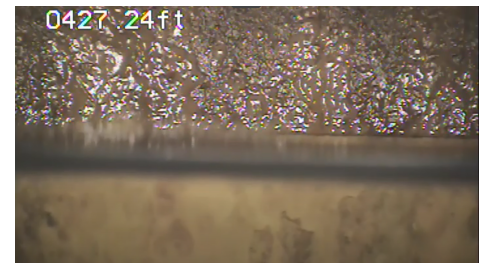
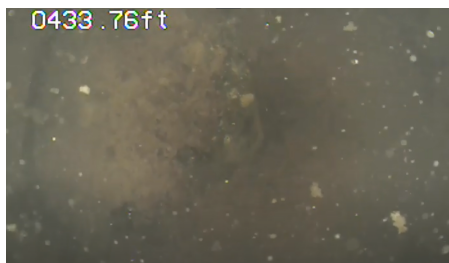
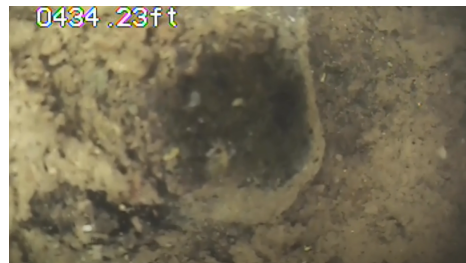
Date: January 23, 2025  
 Depth: 434.24'  
 Water Level: 427.24' Oil? No  
 Operator: Carter Truck: \_\_\_\_\_  
 Tool Zero: \_\_\_\_\_  
 Reason for Video: Inspection

Depth	Video Findings	Casing / Perforation Information	
0-120'	Spider webs	Casing Size:	Depth
434'	Rock at bottom	8"	434.24'
427'	Dirty casing		
		Perforation:	
		427'- 434.24'
